Landslides and related features interpreted from field check 1979-1980

LANDSLIDES AND RELATED FEATURES

OF THE JONES KNOB, TENN. QUADRANGLE
by
Roger E. Thomas and Alfred R. Taylor
1982

U.S. Geological Survey
OPEN FILE MAP 82-653 (B-9)

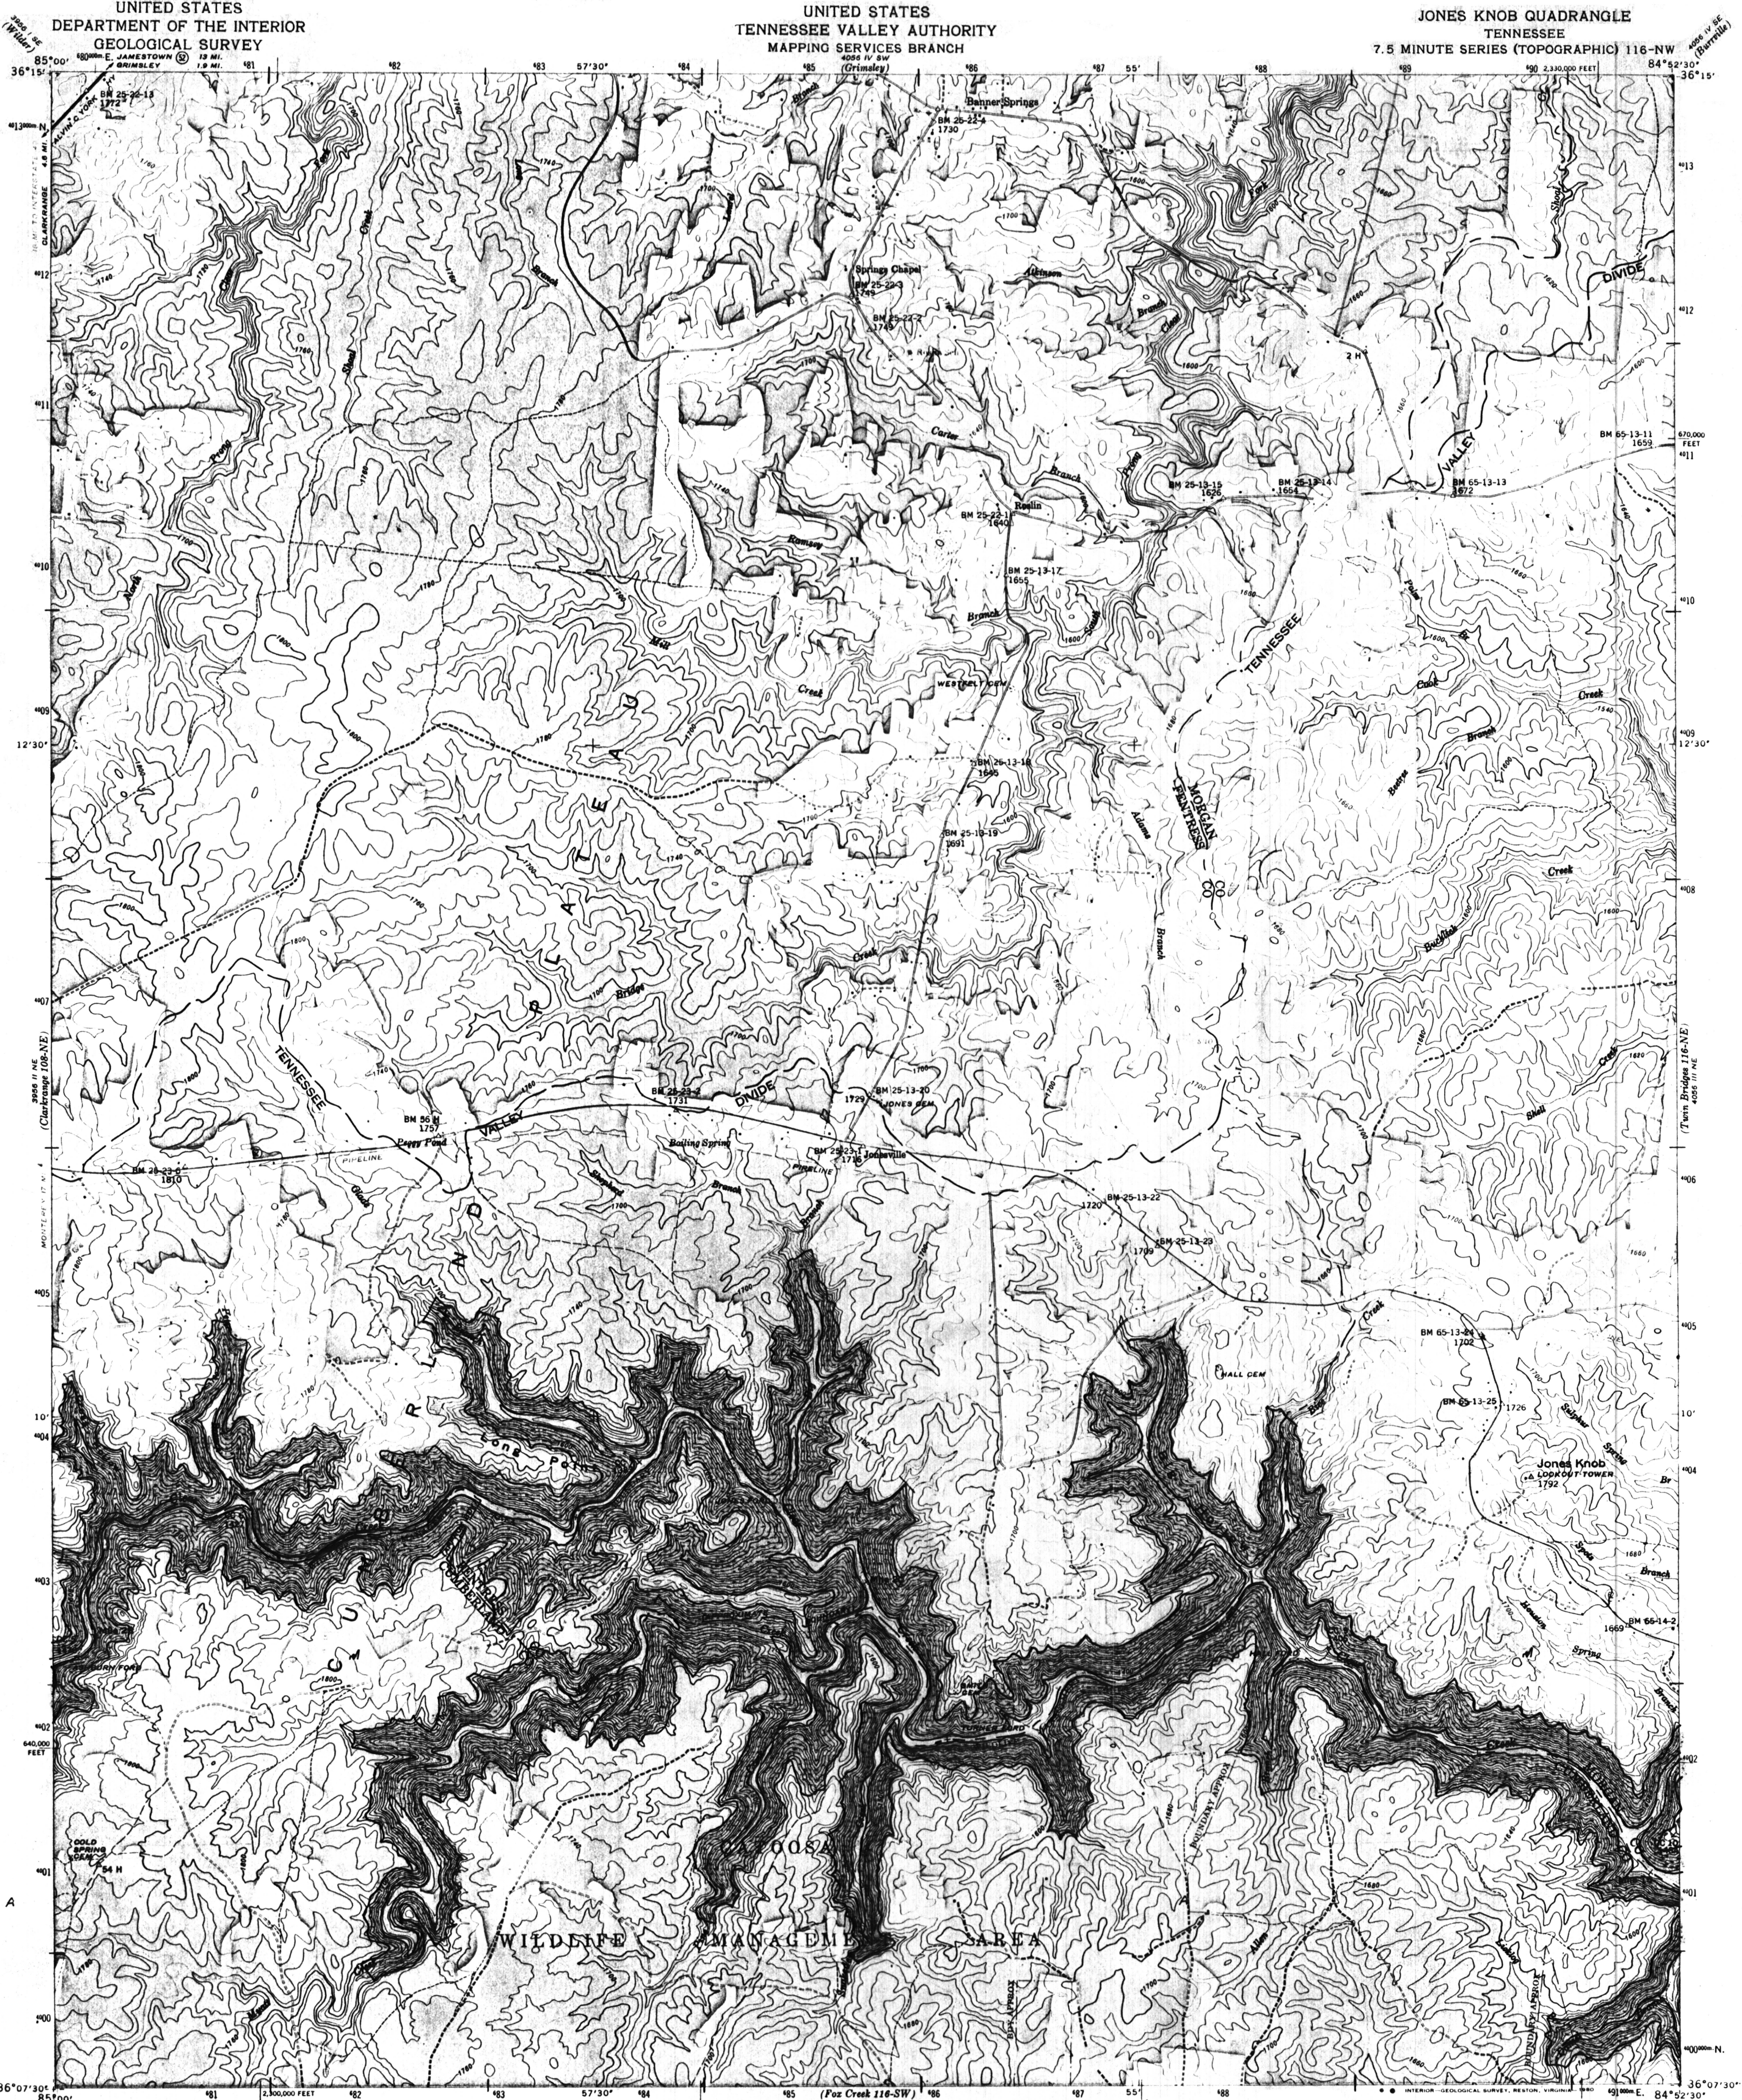
ACTIVE OR RECENTLY ACTIVE LANDSLIDE
Complex landslide composed of earthflow, debris slide, earth and rock slump. Identified from historical records, and from scars, debris and other field evidence. Ground extremely unstable; sliding accelerated by excavation, loading and changes in drainage conditions. May include areas with several active slides too small to be shown separately. Questioned where doubtful.

OLD LANDSLIDE
Area of extensive hummocky ground caused by earthflow and earth and rock slump. Lacks clear evidence of active sliding. Relatively stable in natural, undisturbed state, generally not affected by small structures properly sited in areas away from the edge of the toe; can be reactivated by extensive, rapid excavation, loading, and changes in ground water and surface water conditions. Area of old landslide probably includes recent ones not identified from field evidence or otherwise documented. Upslope boundary of landslide generally defined by modified scarp, but downslope (toe) may be gradational and not well defined. Questioned where doubtful.

COMBINATION LANDSLIDE
Area of recent and old slides in which individual slides are not identified.

COLLUVIAL SLOPE
Valley wall along major streams with slope as steep as 40° (85%); stony, clayey silt soil up to 50 ft. (15 m) thick; commonly buttressed by a terrace or bench at the toe of the slope; very susceptible to sliding by cutting of toe area, removal of terrace or bench, and overloading; slide commonly activated without apparent cause.

COLLUVIAL SLOPES WITH LANDSLIDES
Landslides too small or obscure to map individually.

AREAS SUSCEPTIBLE TO DEBRIS FLOWS AND DEBRIS AVALANCHES
Primarily shallow, narrow ravines and chutes with accumulation of stony colluvium generally 10 ft. (3 m) or less in thickness; susceptible to rapid movement during intense rainfall. Most ravines and chutes designated show evidence of former debris flows and avalanches.

AREAS SUSCEPTIBLE TO ROCKFALL
Steep, locally vertical, natural and man-made slopes and cliffs, 15 ft. (4.5 m) or more high; formed dominantly of sandstone, limestone, sandy shale, mudstone and claystone. Interbedded mudstone, claystone and shale weather rapidly leaving sandstone and limestone rock faces unsupported.

SOIL AND ROCK SUSCEPTIBLE TO LANDSLIDING
Soil and rock similar to that involved in landslides elsewhere in map area; primarily areas underlain by claystone, mudstone and shale associated with other rock types. Rock weathers rapidly on exposure forming clayey soil highly susceptible to sliding. Includes coves (U-shaped, shallow valleys) containing thick layers of clayey soil that are very susceptible to sliding where excavation breaks continuity of slope and where overloaded by artificial fill.

AREAS LEAST PRONE TO LANDSLIDES
Map areas in which no patterns or symbols are shown; primarily valley floors, ridge tops and broad benches; modification by excavation and fill may lead to local landslides.

MAN-MADE FEATURES
Strip mines (combination of letter symbols indicates complex formed of more than one type of strip mine)
sh bench with high wall
sf furrowed with high wall
sd multiple furrows and multiple benches
ss hilltop removed
srg reclaimed by grading
sru reclaimed by secondary use
sh/r regraded in part, high wall remains
Coal refuse banks
r identified on aerial photographs; not classified in field check
rb not burnt nor on fire
rbb burnt
Quarries
q quarry site
Gravel pits
g site of gravel pit
Slides in man-made features
af earth flow in fill
a/s earth flow in strip castings
a/r earth flow in coal refuse
